# Basic Detail Report

## May-Belle

HV000534

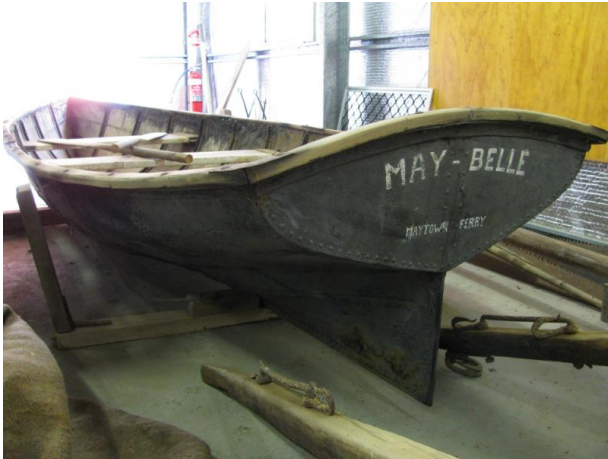
MAY-BELLE was designed and built c1895 to ferry passengers and small amounts of cargo such as mail and supplies across the Palmer River at Maytown (north Queensland) in times when the river was in flood and could not be crossed by any other means. The passage was about 200 metres over water up to six metres or so depth, and relatively fast flowing. This required an open boat fitted with thwarts for seating and rowing as the logical choice for the period, and similar boats were used in many locations for this purpose all around Australia. MAY-BELLE has a conventional dinghy or waterman's skiff style and proportions to its 4.66m length, giving it a nice sheered hull profile, rounded stem and angled transom. There is a hollow toward the keel in the bottom sections aft that forms a keel toward the transom for steering control. It has been identified as a close sister ship to another flood boat in Coen (HV000546) on the Archer River, north of the Palmer River because it shares virtually identical dimensions, the same shape and same construction method. MAY-BELLE has been built in thin gauge iron or steel plating on angle bar frames. This choice of a heavy material is slightly unconventional, because typical craft of this type would have been made in wood, either carvel or lapstrake planked. However, the dry inland environment for much of each year, where the craft would have remained out of the water for long periods would have been unsuitable for a wooden craft, which would have opened up at the seams whilst out of the water. It would not have been usable immediately when required as the seams take some days to swell and close up again. It is also possible that the extreme nature of the dryness could have caused the wood to split making the craft unusable. Therefore the choice of a metal plated hull seems quite suitable, with the only major issue being corrosion or rust. However, the likely service life expected was measured in years or a decade or so at best, in which time any corrosion leading to holes could be plated over if needed. A metal hull would also be more resistant to damage, and the many dimples and deformed areas on the existing hull show how it could absorb the damage but remain intact, even though the surface became somewhat misshapen. A metal hull could also be more easily repaired, as the skills required were within a blacksmith's trade, a common occupation throughout inland locations. MAY-BELLE has a very simple layout. It is an open boat with no decking. The bilge is completely open, and there may have been floorboards across the frames to keep cargo clear of any bilge water and act as a sole to step on. Four thwarts are fitted, and the forward two have rowlock holes. No oars or rowlocks exist that relate to the craft. Whilst it is clear MAY-BELLE could have been rowed which is the natural form of propulsion for this type of craft, the strong

current raises the question as to whether there was a cable or flying fox between the shores, which some how attached to the hull to keep it from being taken downstream from where it was to land on each shore. According to one source it used a set up below a bend, which had a steel/iron stake hammered well into the ground. This stake, or a suitable tree, was used to secure a rope or wire to hold the boat's bow upstream while it was pulled across by line, which allowed a greater load and fewer crew to be aboard. MAY-BELLE's early details are still being researched, and the first reference to it comes in the North Queensland Register 8 May 1895. Reporting on a flood on the river and accident to a mail coach, the story notes that the existing 'Divisional Board Ferry boat' was lost in the torrential river flow, and then went on to state that a new one was already available. "Fortunately the Board has a new boat ready at the LAURA, only awaiting transport. Our indefatigable Chairman took prompt action to have the boat brought up. The boat comes from the well-known firm of Sutton and Gay, Brisbane, and cost 39 pounds delivered on board the Steamer.' This was the Palmer River Goldfield Divisional Board, and they were the original owners of the vessel. Mary Callaghan was a resident in Maytown and recalled having rides in the boat as a child and that it was stored in a shed and had a winch and a trolley to launch it into the river. Her mother stated that in 1911 when another flood occurred, it washed the vessel downstream a couple of miles before it could be recovered. At this time it may well have belonged to a subsequent regional authority. Maytown was finally abandoned in the late 1940s after the last person living there departed, but it had been virtually deserted and no longer active for many years beforehand. How and when it was named is not yet known, but when MAY-BELLE was recovered and brought to Cooktown Doug Keeble who had knowledge of Maytown understood that it was called MAY-BELLE and that name has remained with it. MAY-BELLE was discovered in 1973 by a group of teachers who had remained in Maytown for a short period after a safari party had returned to Cooktown. They had been looking through the deserted township. Walking through the dry river bed of the Palmer River they came across the upturned hull largely covered by bushes. They reported their find to Darcy Gallop who had led the safari tour, and he was also both the Cooktown administrator and board member of the James Cook Museum. Understanding the significance this vessel had as an artefact of the Maytown gold mining period, Darcy Gallop returned to Maytown with a couple of council workers, and using a 3 tonne truck and winches they removed the vessel from the scrub and brought it back to Cooktown. He then replaced the thwarts with new ones, and painted the outside. It was then stored at the James Cook Museum. In 2012 the May-Belle remains stored at the James Cook Museum and is an object in the collection registered as JC.99.735. It has been cleaned and remains in good condition with the structure intact. The museum intends to document the craft further and build a new cradle to give it better support. Maytown is now deserted and only remains of some of the structures including the boat-house are visible on the site. .

Vessel Dimensions: 4.66 m x 1.55 m (15.3 ft x 5.1 ft)
